REMOVAL OF THE COLUMBIA MILL DAM, LEE, MASSACHUSETTS Site Reconnaissance and Cost Estimates

June 2008

Prepared For
MASSACHUSETTS RIVERWAYS PROGRAM
DEPARTMENT OF FISH AND GAME
251 CAUSEWAY STREET, SUITE 400
BOSTON, MA 02114

PREPARED BY
STANTEC CONSULTING
30 PARK DRIVE
TOPSHAM, ME 04086

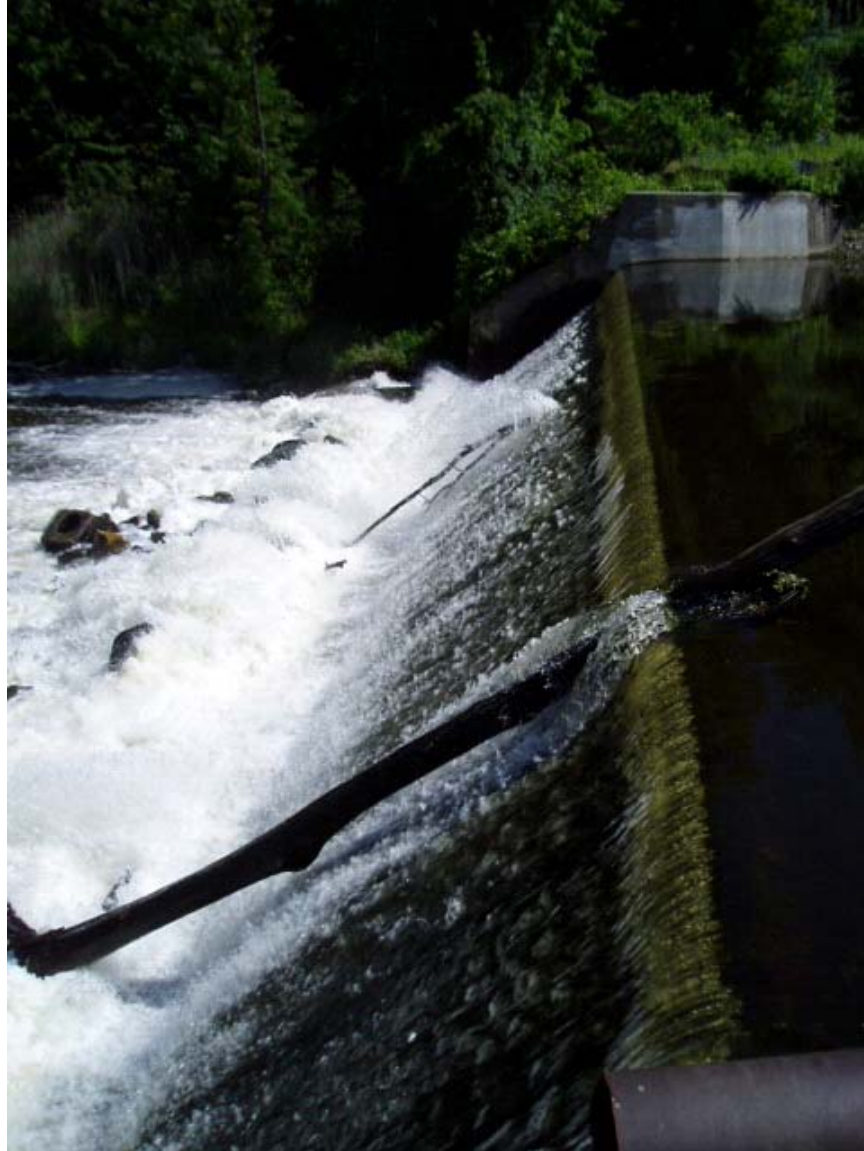
Photo 1. Columbia Mill Dam from left bank with woody debris.

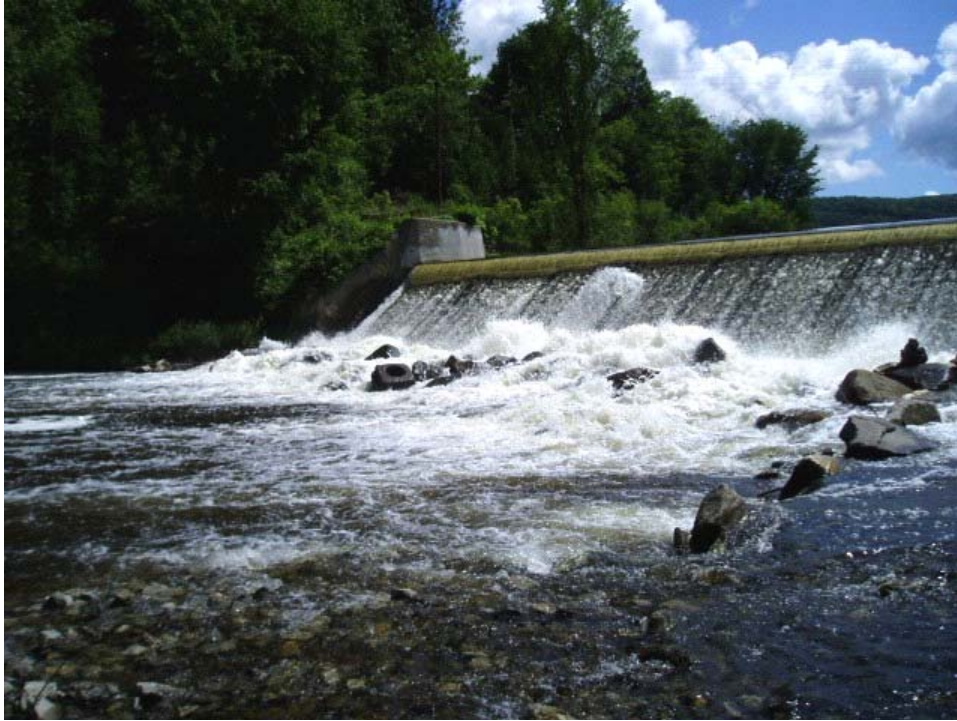
Photo 2. Upstream view of Columbia Mill Dam.

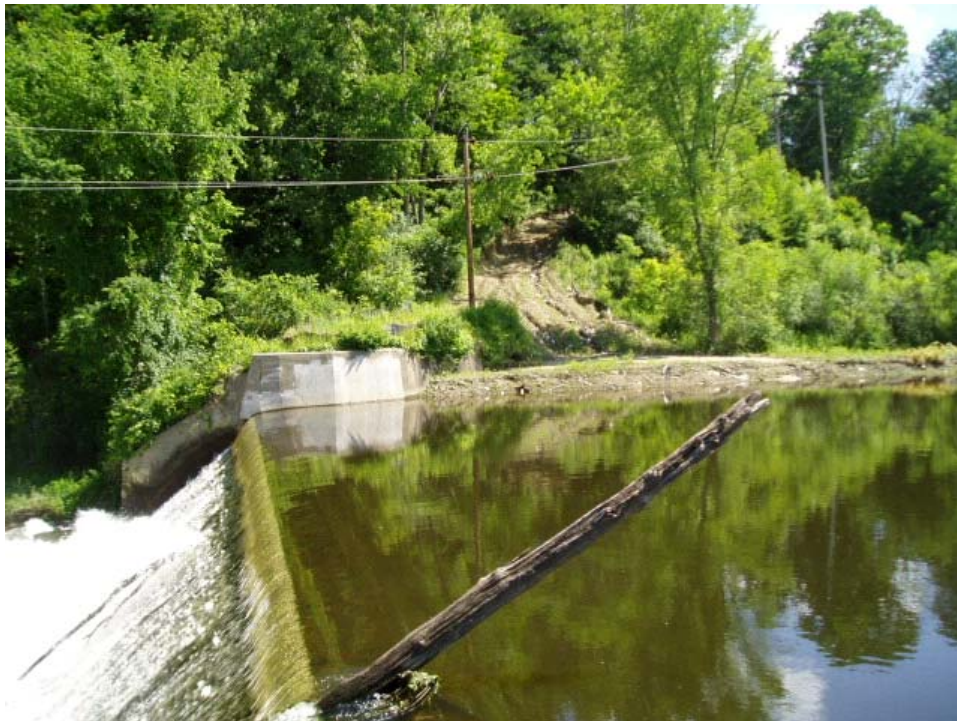
Photo 3. Columbia Mill Dam from left bank showing potential construction access road.

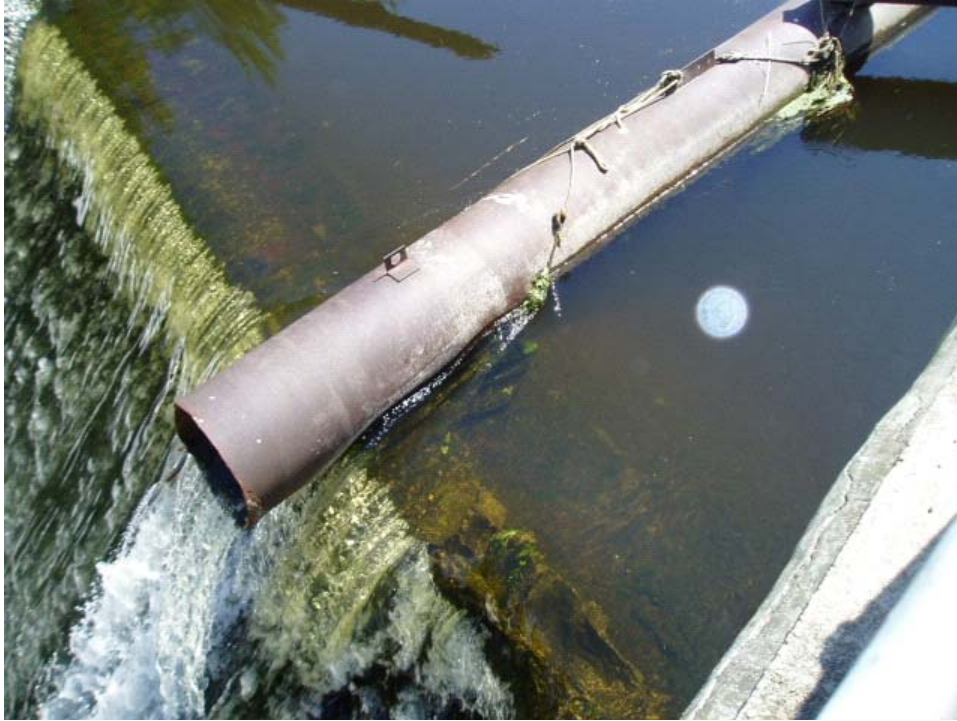
A waste water discharge pipe is located atop the Columbia Mill Dam. Mr. Scheurer indicated that all discharges from the Columbia Mill are done via this discharge by way of a National Pollution Discharge Elimination System (NPDES) waste water treatment plant outfall permit.

Photo 4. Spillway of Columbia Mill Dam with mill process water effluent pipe.

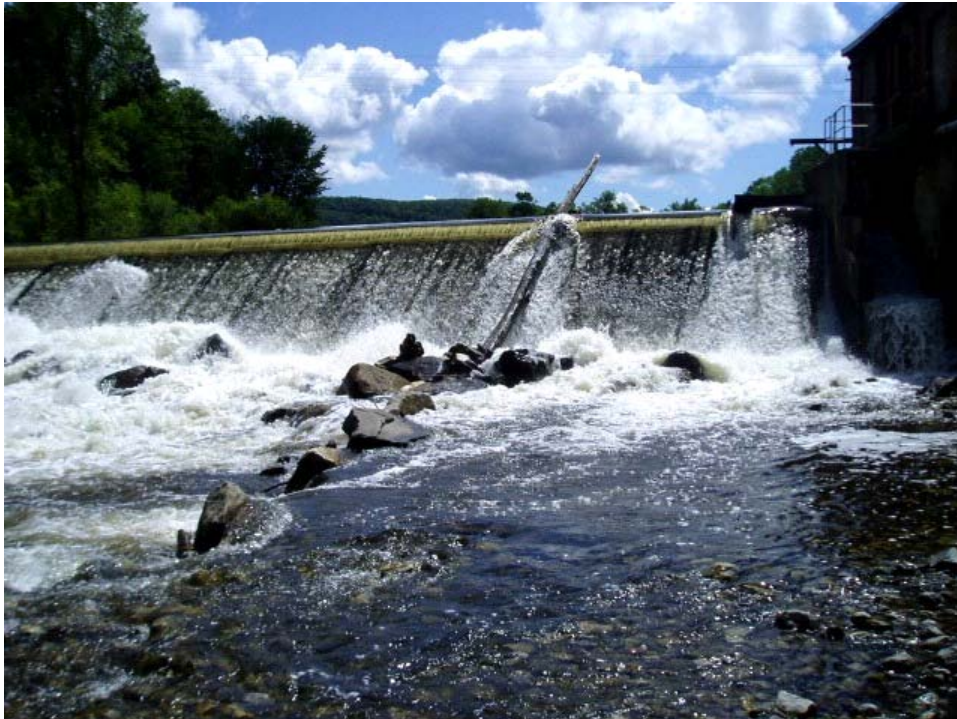
Photo 5. Upstream view of Columbia Mill Dam.

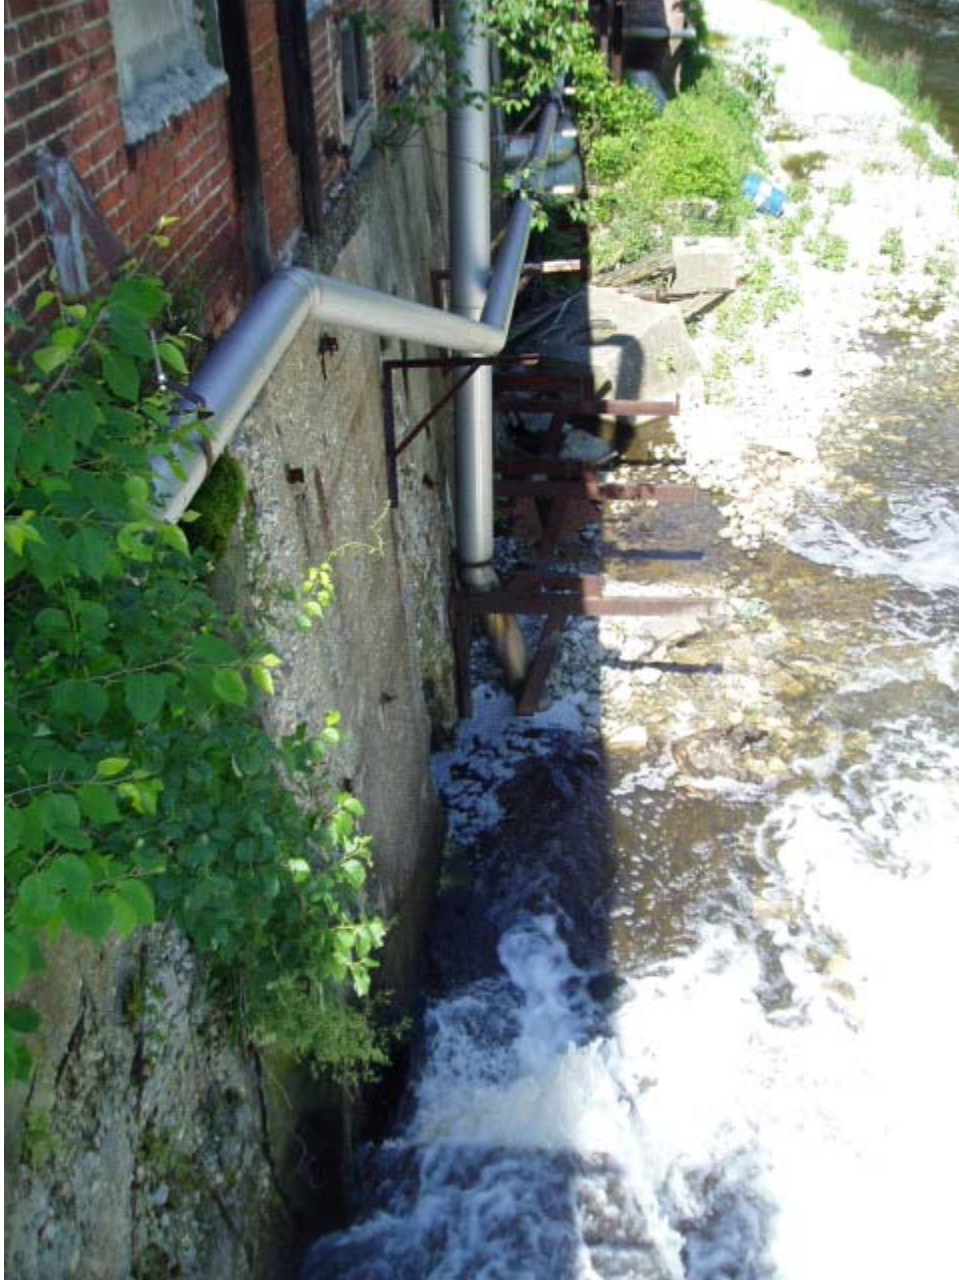
Photo 6. Downstream view of Columbia Mill on river left, adjacent to Columbia Mill Dam showing second potential construction access road.

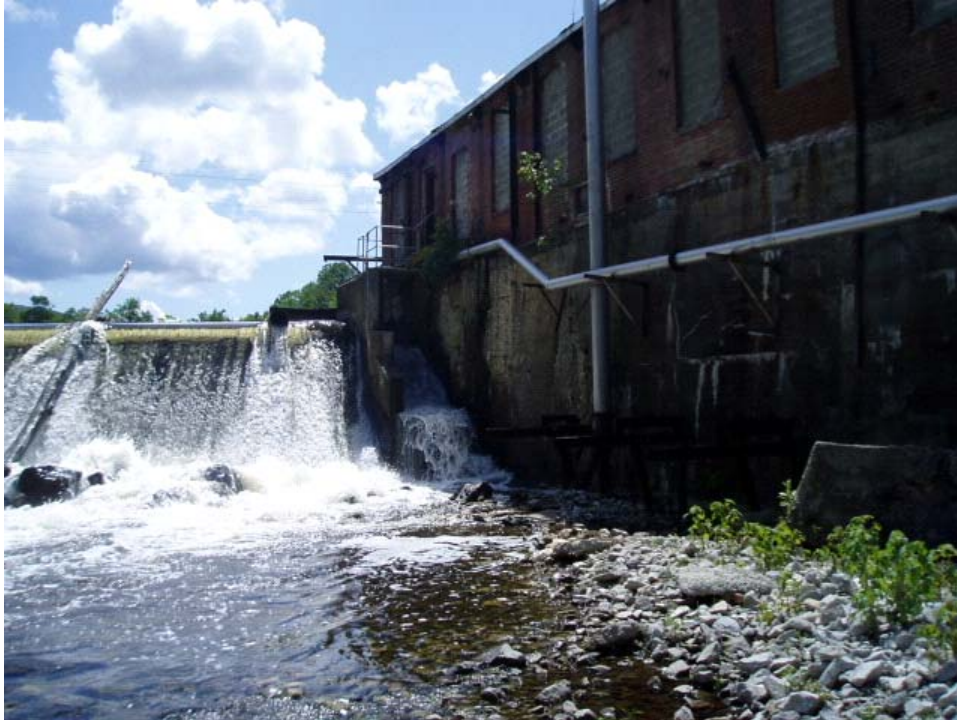
Photo 7. Upstream view of Columbia Mill and Columbia Mill Dam.

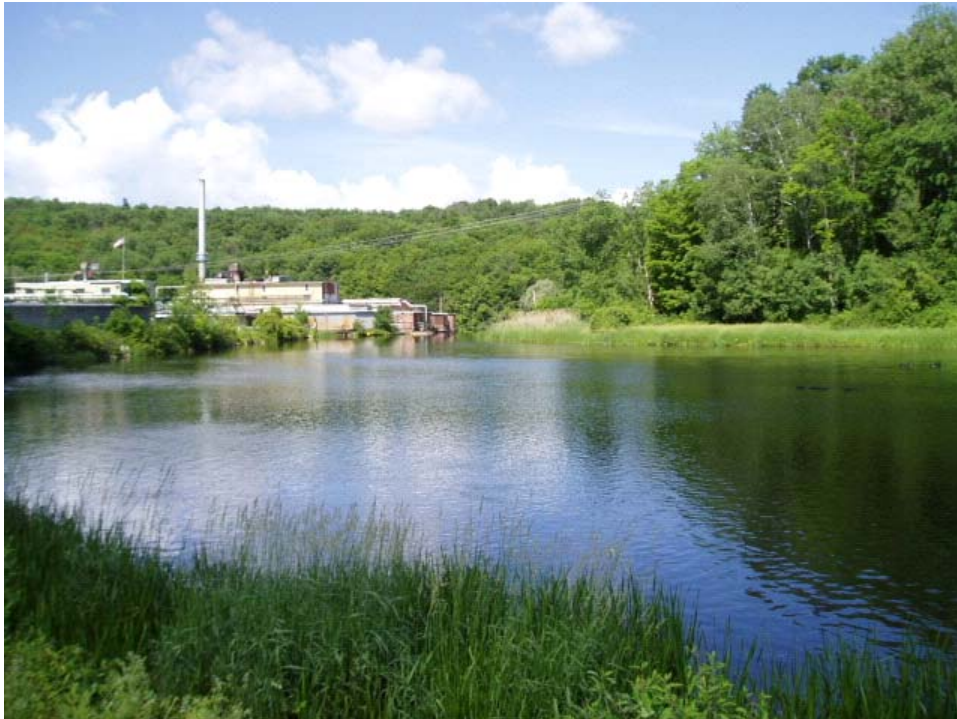
Photo 8. View of Columbia Mill and Columbia Mill Dam impoundment.

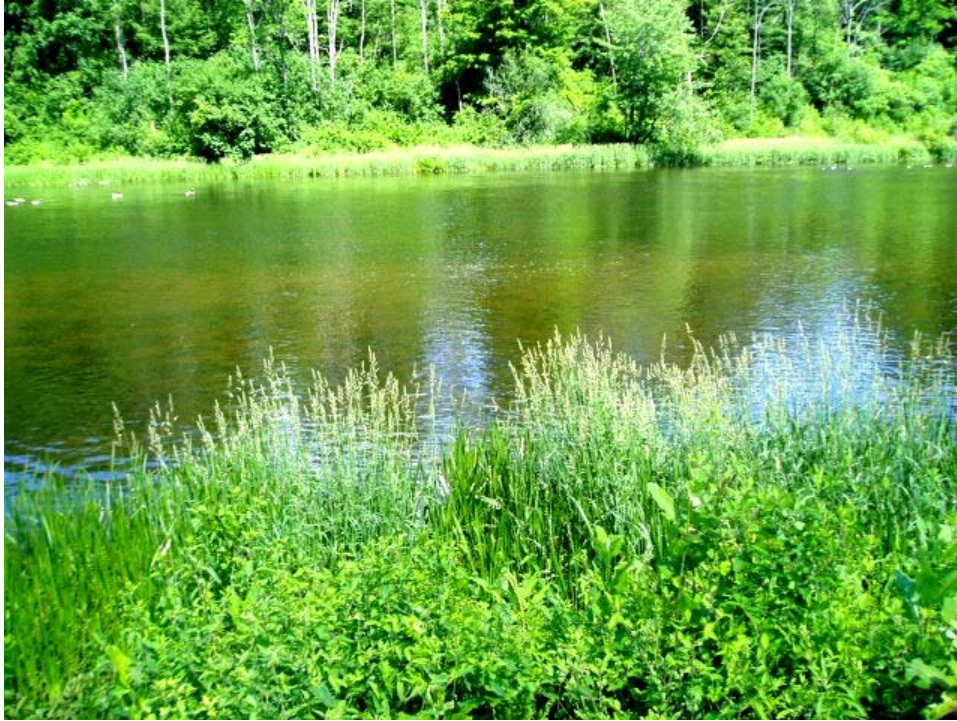
Substrates in the impoundment vary and appear to be dominated by relatively small mineral material (e.g., sand), silt, and organic detritus. Some remnants of the natural streambed were noted from photos contained within the TBI dam modification report, including cobbles in the immediate vicinity of the Dam and mill complex river water intake screens. The apparent coating of silts and sand material over this cobble layer and the readily viewable sandbar approximately 500 feet upstream from the Dam indicates that the impoundment traps inflowing sediments. The observed character and composition of the aggraded material in the impoundment suggest that habitat for riverine benthic organisms is limited and degraded compared to reach locations upstream and downstream from the impoundment.

Given the former industrial nature of the Housatonic River upstream of the Columbia Mill Dam impoundment, it is likely that the aggraded material contains industrial wastes, including polychlorinated biphenyls (PCBs). Given the moderate river gradient upstream of the impoundment and relatively narrow impoundment width, it is likely that sediments may become re-suspended in the water column seasonally during high flow events.

Photo 9. View of aggraded sediment in the impoundment (approximately 1,800 feet upstream from Columbia Mill Dam).

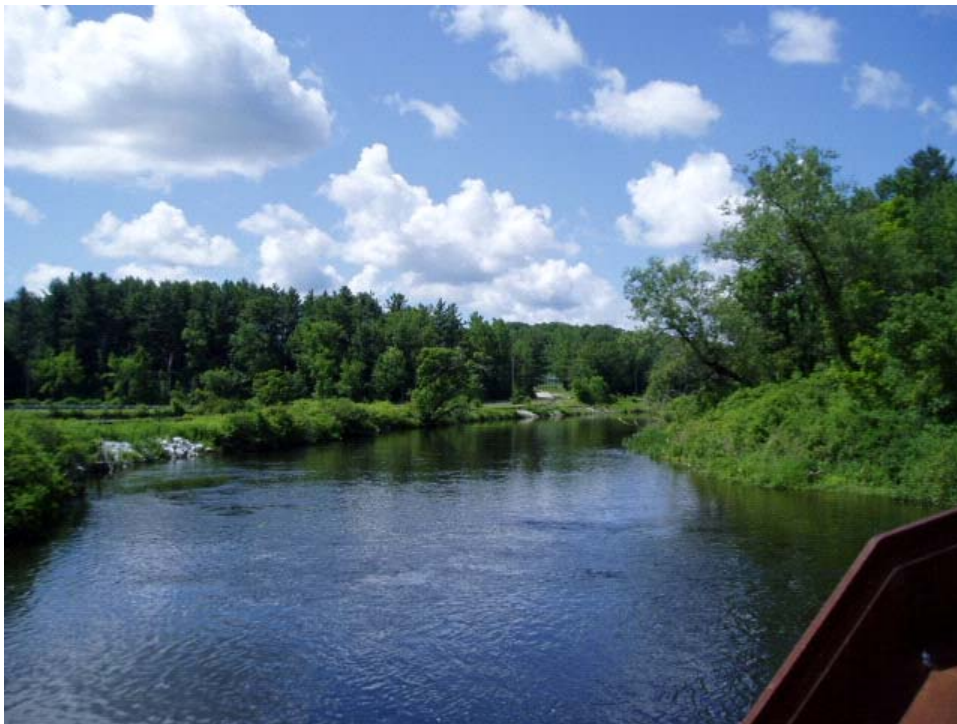
Photo 10. Housatonic River looking downstream from the bridge on Golden Hill Road.

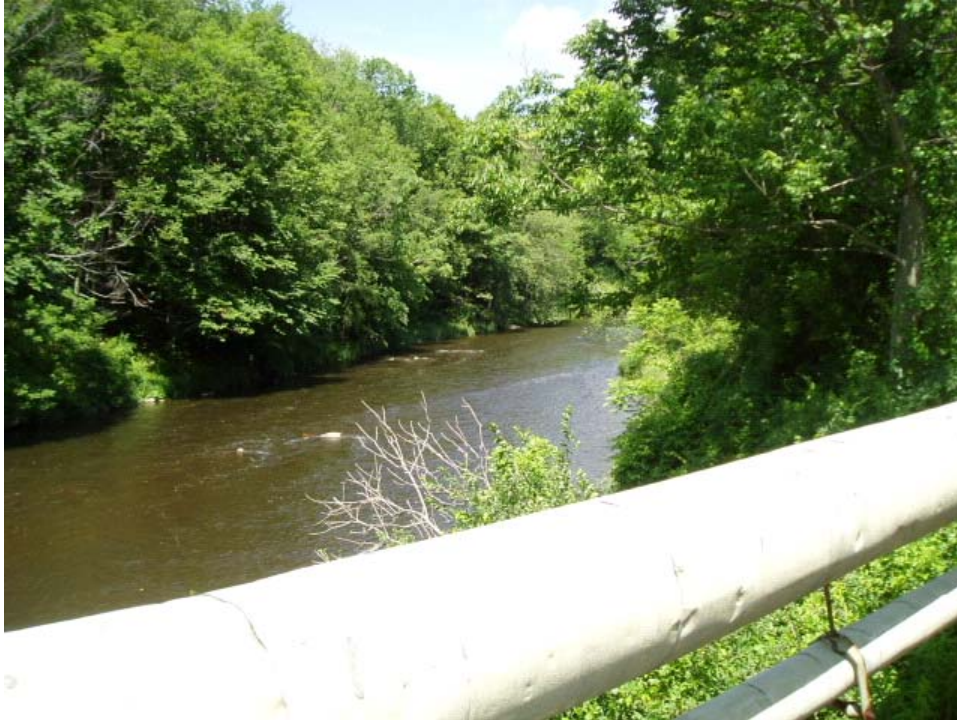
Two pipes continue within the river channel downstream from the Dam. It is assumed that they serve the Eagle Mill facility, although the turbid nature and elevated flood stage on the day of the site visit prevented Stantec from confirming this. One pipe exhibited some hydraulic control on the river, as noted by a change in water surface elevation in the vicinity of the pipe; however, it is unclear whether this pipe influences fish passage at lower flows. A third pipeline that runs outside of the wetted channel, parallel to the railroad tracks down to the Eagle Mill complex, was undergoing demolition at the time of the site visit.

A subsequent communication with SMII employee Roger Scheurer indicated that all three pipes noted during the June 19, 2008, site visit belong to SMII, serving as connections between the upstream Niagara Mill, Columbia Mill, and downstream Eagle Mill facilities. Mr. Scheurer indicated that all three pipe lines are no longer used and considered disposable as a result of the mills shutting down.

Photo 11. View of in-stream pipe alignment below Columbia Mill Dam (straight line in water). Note that pipe in foreground is currently undergoing removal.

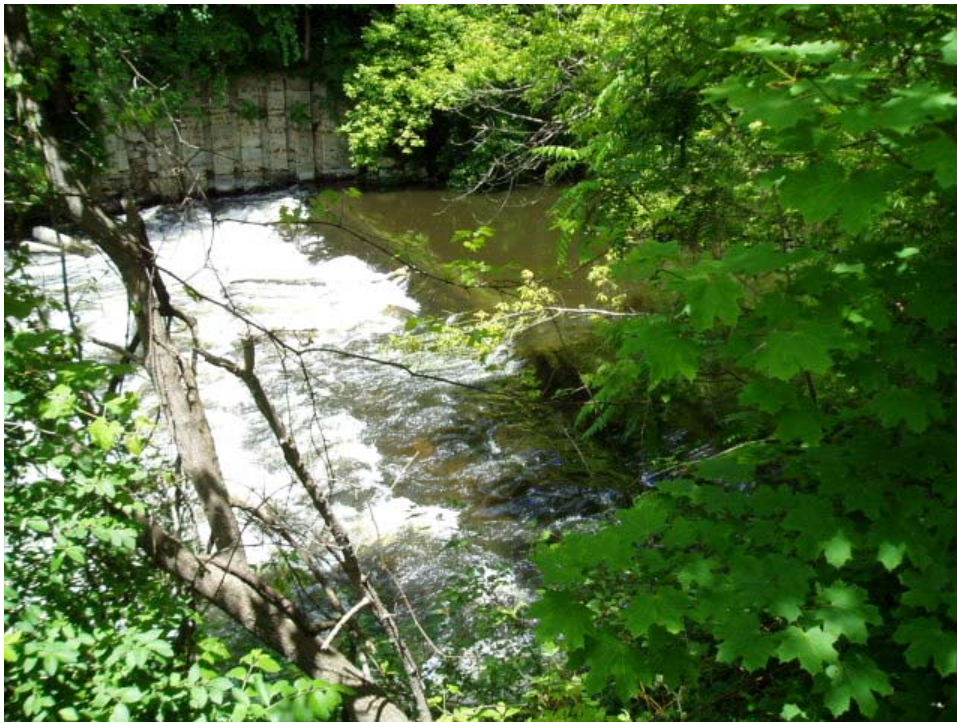
Only the timber cribwork foundation framework and right bank abutment remain. Much of the cobble and boulder cribwork fill material has been washed downstream. The remaining timber cribwork presents a hazard to boaters as it contains many metal spikes that create an entrainment situation. Fish passage is presumed to be seasonal, as the timber cribwork may present a barrier to migration at lower flows. The dam remnants create an approximately three-foot rise in river grade, creating potential for some aggraded material in the shallow impoundment above. Dam removal or reconfiguration of the timber crib work structure to enhance fish passage or remove anthropogenic boating hazards should be subject to the same considerations regarding sediment testing and management as described above for the Columbia Mill Dam.

Photo 12. View of Eagle Mill Dam remnants from left bank.

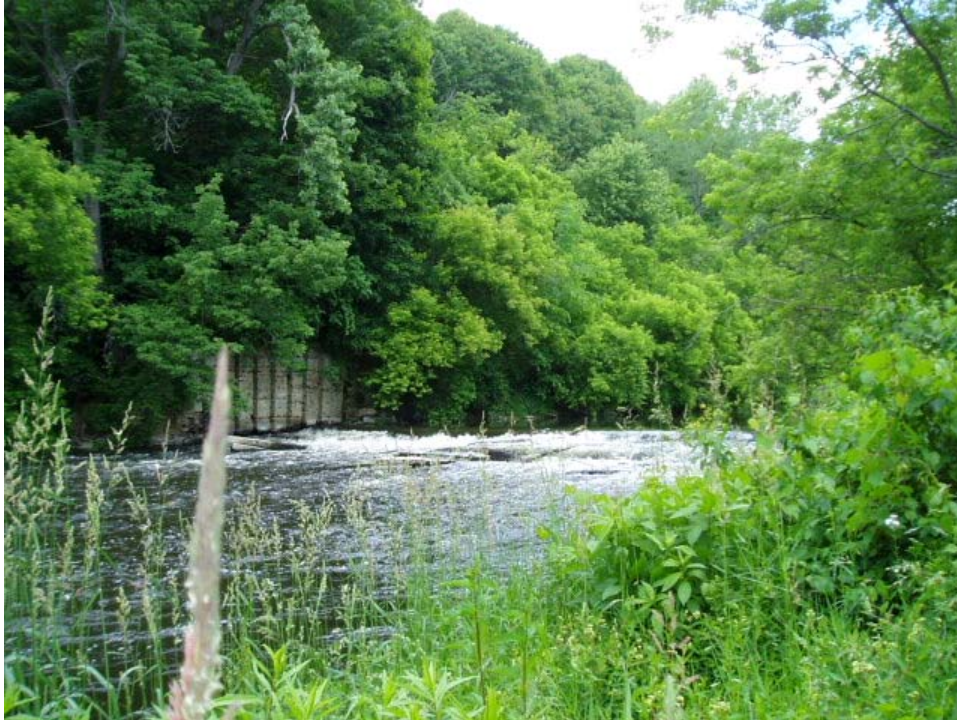
Photo 13. View of Eagle Mill Dam remnants from downstream.

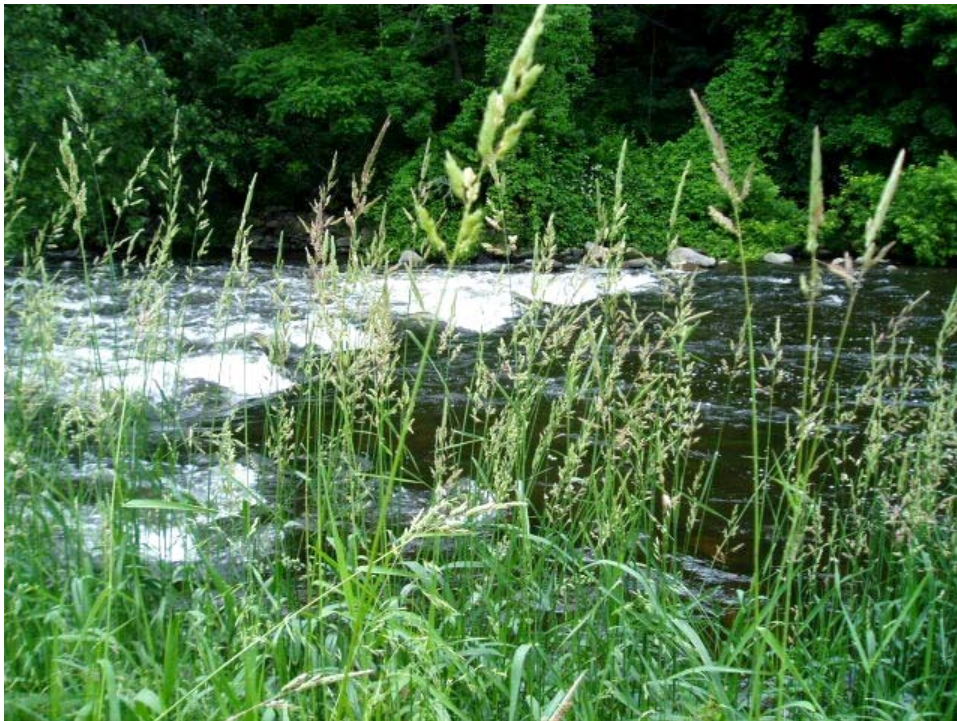
The tailout of the downstream scour pool appears to have collected much of the Eagle Mill Dam remnants, creating a downstream hydraulic control approximately 1 foot high, 75 feet below the Eagle Mill Dam site. At the time of the inspection, elevated water conditions in the river prohibited an assessment of this structure. However, it is assumed that the structure does not provide much of a hindrance to fish passage.

Photo 14. View of downstream hydraulic control 75 feet below remains of Eagle Mill Dam.

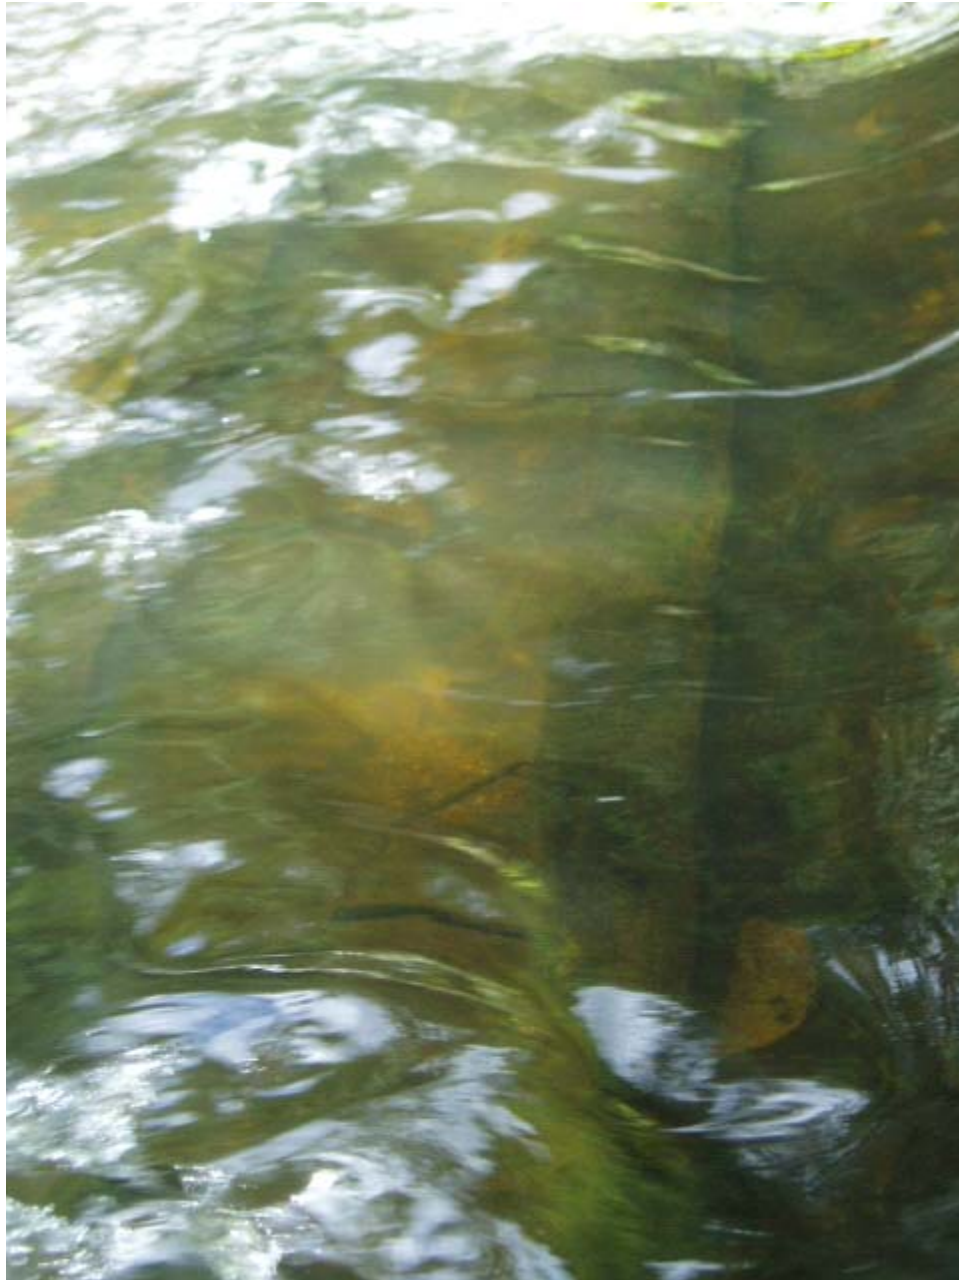
Photo 15. Close up view of Eagle Mill Dam remnants. Note cribwork alignment perpendicular to channel alignment and large metal spikes.

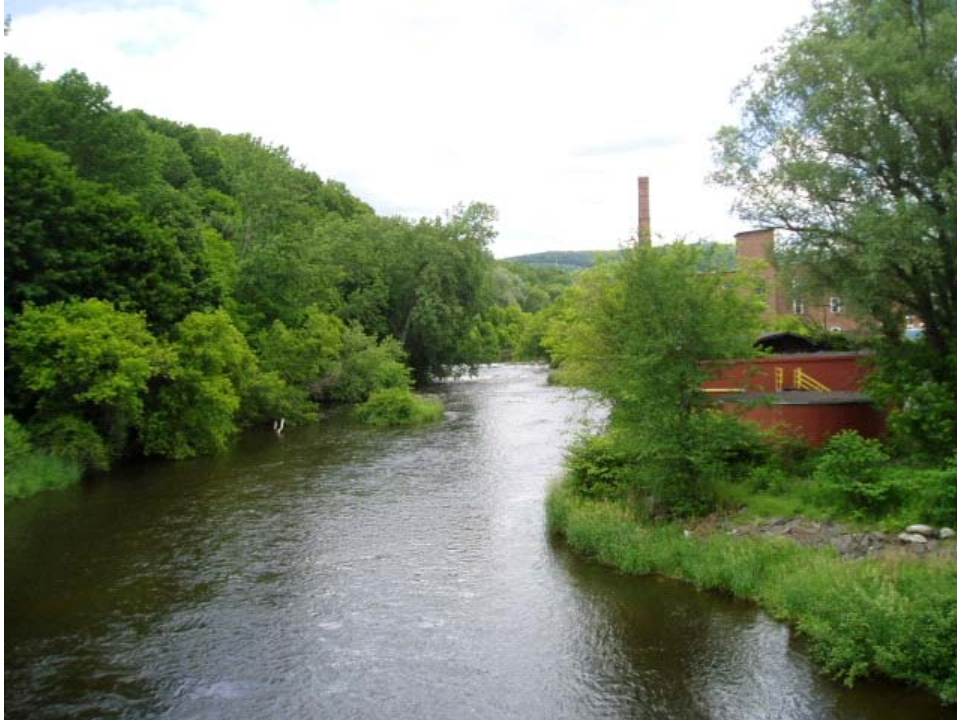
**Photo 16. View of Eagle Mill and Eagle Mill Dam remnants looking upstream from
Route 20 bridge.**
